Subject: Special Management Area Use Permit Assessment Application – Minor
Hālau Maluhia Improvements
Tax Map Key: 8-3-04:por. 001
Ke'ei, South Kona, Hawai'i

Archaeological Assessment for Wastewater System Improvements

Lands of Ke'ei I and II, South Kona, Hawai'i
TMK: (3) 8-3-06:019, 030, 033 and TMK: (3) 8-3-04:Por. 001

Thomas S. Dye, PhD

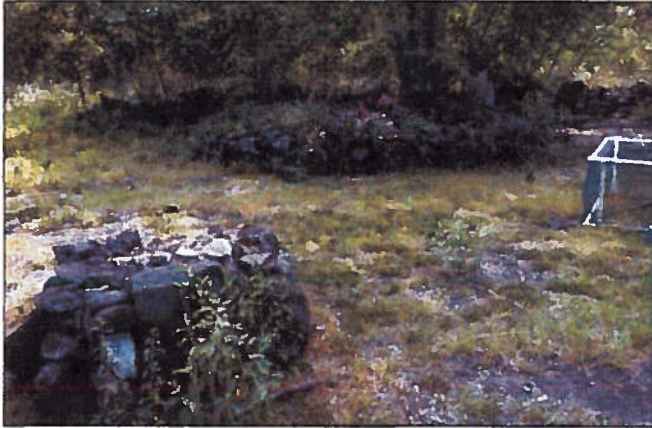
The area of potential effect is an open yard location between the carport and two rock platforms at the east end of the parcel. The smaller of the two rock platforms (fig. 3, *a*) is

freestanding, but the larger rock platform (fig. 3, *b*) abuts, and is younger than, the wall surrounding the parcel. In plan view, the larger of the two rock platforms has distinctly rounded corners.

Figure 3: Photograph of the backyard in the vicinity of the proposed facility location at parcel 19, looking east. Note the small platform in the left foreground and the large platform in the background with the photo scale. The scale is marked in 10 cm increments.

Inspection of parcel 19 failed to yield any evidence of potentially significant cultural deposits. When queried, William Panui reported that the sediment deposit over most of the parcel is less than 3 in. thick and that he had never found traditional Hawaiian artifacts at the parcel. Inspection also failed to reveal any petroglyphs on exposed *pāhoehoe* outcrops within the area of potential effect (APE). William Panui also reported that he hadn't discovered any petroglyphs on the parcel.

The unusual shape of the large rock platform, with its rounded corners, and the fact that it was built after the parcel's enclosing wall are two indications that it is a fairly recent construction. Dale Fergerstrom noted that a previous occupant was an amateur radio operator who built the large rock platform as a foundation for an antenna. According to Fergerstrom, the small rock platform marked the location of a guy wire anchor for the antenna. This information is consistent with field observations.

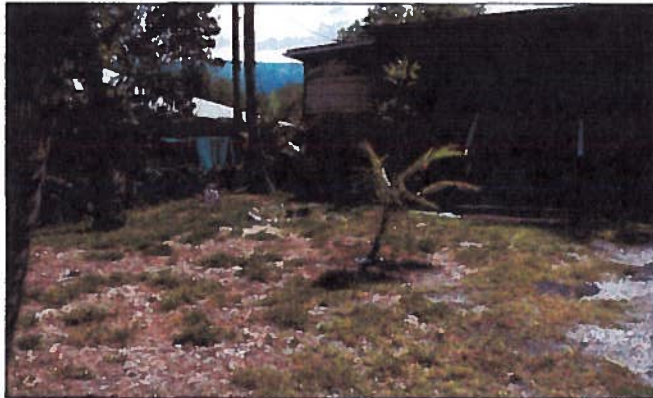
Wastewater system improvements are proposed for the front yard, *makai* of the existing dwelling. The area of potential effect for the wastewater system improvements is confined to the areas that will be excavated, as shown on figure 4, and to the driveway, which will be used to stage construction and lay down materials. The APE is an open yard with a shallow cover of calcareous sand that supports mature and young coconut trees and some grass (fig. 5). No evidence of a potentially significant cultural deposit was seen in eroding

sections of this sand deposit alongside the driveway. Rings of coral cobbles around some plants in the front yard are obviously recent constructions.

Figure 5: Photograph of proposed facility location at parcel 30, looking northeast.

No petroglyphs were found on exposed patches of *pāhoehoe* lava within the APE at parcel 30.

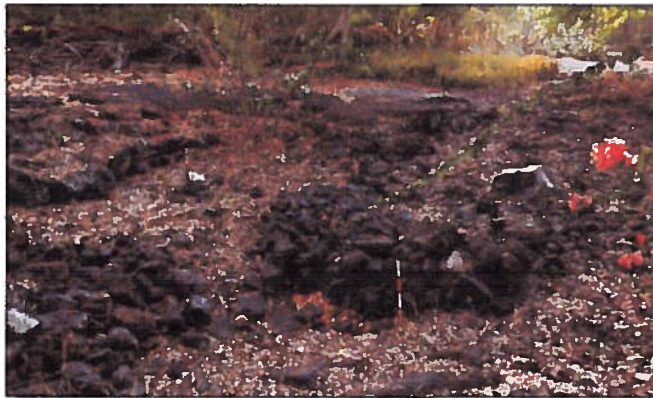
Field observations indicate that the enclosure wall abuts the lot boundary wall and thus postdates it. It was not possible to determine the stratigraphic relation of the platform

with the lot boundary wall without excavation. Field observation of the small semicircular enclosure did not yield any information about its age or function.

Figure 7: Photograph of proposed facility location at parcel 33, looking west. The small semicircular enclosure near the photo scale was built by Lawrence Grace. The scale is marked in 10 cm increments.

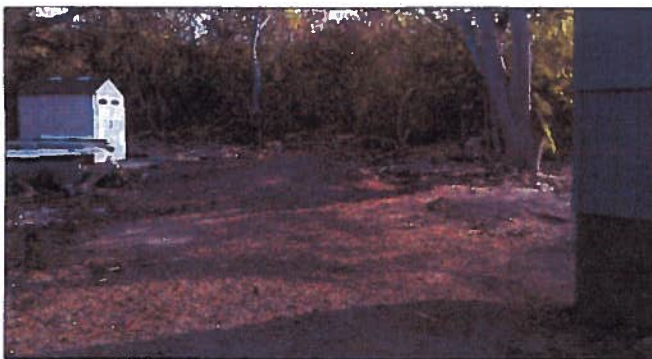
Field observation of the APE yielded no evidence for potentially significant historic properties. The various stone walls that show on the engineering map (fig. 8) are all

Figure 9: Photograph of proposed facility location at Halau Maluhia, looking east.

modern structures associated with construction and use of Halau Maluhia. The ground surface is generally bare of natural sediment east and north of the large, open building, so there is no likelihood of significant buried cultural deposits.
