STATE OF HAWAII
DEPARTMENT OF LAND AND NATURAL RESOURCES
OFFICE OF CONSERVATION AND COASTAL LANDS
POST OFFICE BOX 621
HONOLULU, HAWAII 96809

SUBJECT: Unauthorized Sand Placement Within the Conservation District Located at Manini Beach, Kealakeakua Bay, South Kona, County of Hawaii, TMK: (3) 8-2-006:027

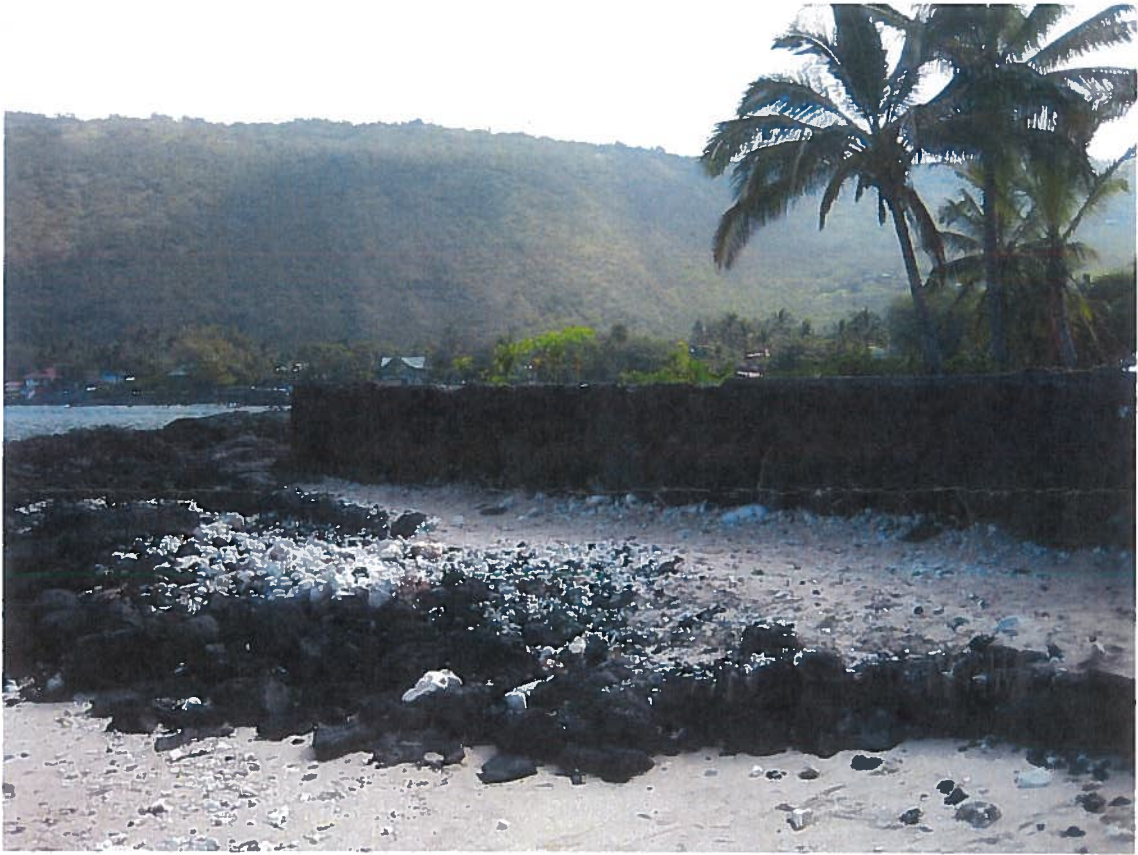
EXHIBIT A

The adjacent shorelines were also inspected for sand and rubble caused by littoral processes. (Exhibit A). Parcel 27 has white sand with coral rubble. The nearby roadway/parcel 10 does not have white sand or coral rubble introduced by littoral processes.

Parcel 27 illustrates sand and carbonate rubble on shoreline

violation has occurred. Much of the introduced sand has dissipated and mixed with the darker sand of the Kealakeakua cell. As the introduced sand appears to have been of a small quantity, appears to be native beach quality sand and does not appear to be detrimental to the ocean resource, the OCCL is recommending that the matter be resolved through our Civil Resource Violation System (CRVS).

A CRVS notice shall be forwarded to the Bill Healy Foundation to hopefully resolve this matter. Any additional sand placement within the Conservation District at this subject location, without authorization, shall be vetted by the Board of Land and Natural Resources.

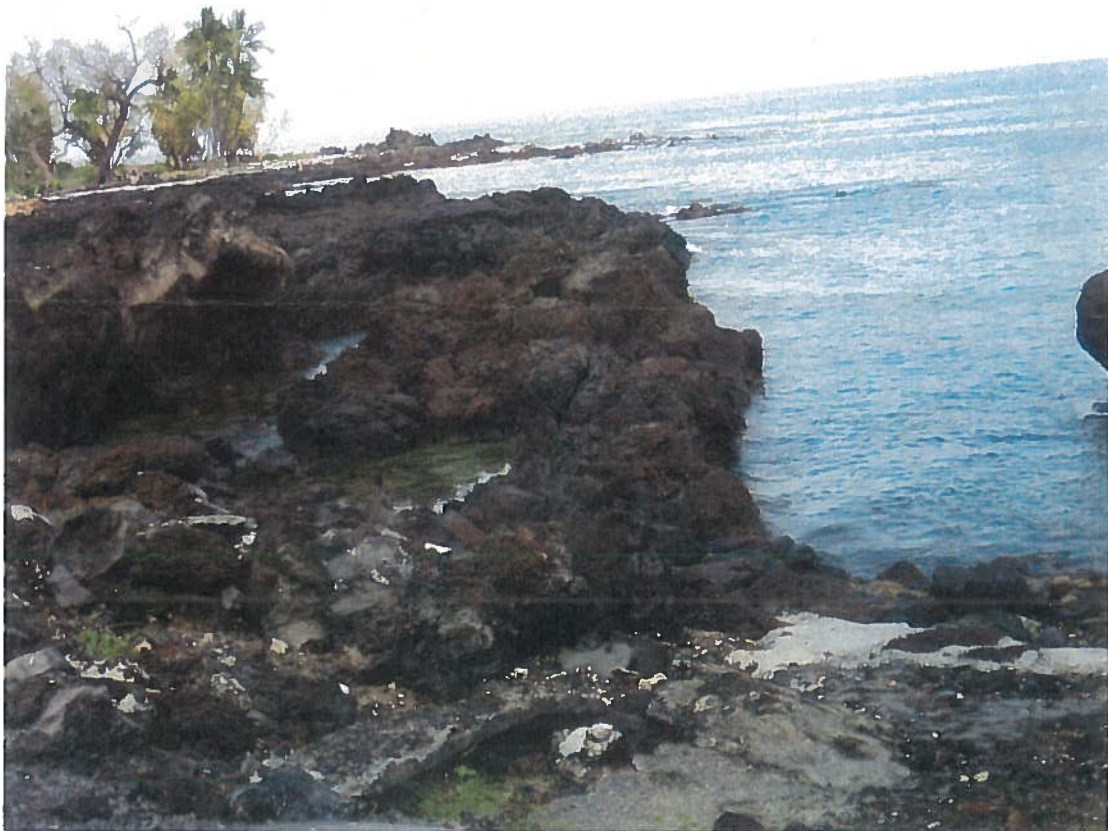
Nearby Road/Parcel 10 illustrates no sand or rubble from littoral processes
