Subject: Special Management Area Use Permit Assessment Application – Minor
Hālau Maluhia Improvements
Tax Map Key: 8-3-04:por. 001
Ke'ei, South Kona, Hawai'i

Archaeological Assessment for Wastewater System Improvements

Lands of Ke'ei I and II, South Kona, Hawai'i
TMK: (3) 8-3-06:019, 030, 033 and TMK: (3) 8-3-04:Por. 001

Thomas S. Dye, PhD

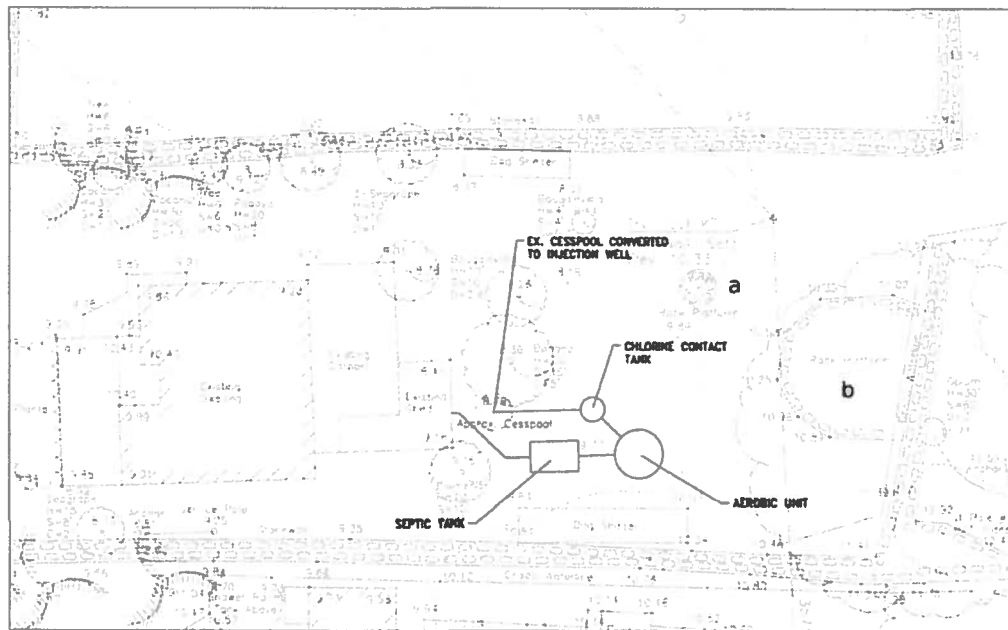
Figure 2: Engineering map showing the location of proposed wastewater facilities on parcel 19 and rock platforms: *a*, small platform; *b*, large platform.

Wastewater system improvements are proposed for the backyard, *mauka* of the existing dwelling. The area of potential effect for the wastewater system improvements is confined to the excavations that will be carried out, as shown on figure 2, and the driveway, which will be used for construction staging and laying down materials.

The area of potential effect is an open yard location between the carport and two rock platforms at the east end of the parcel. The smaller of the two rock platforms (fig. 3, *a*) is

freestanding, but the larger rock platform (fig. 3, *b*) abuts, and is younger than, the wall surrounding the parcel. In plan view, the larger of the two rock platforms has distinctly rounded corners.

Inspection of parcel 19 failed to yield any evidence of potentially significant cultural deposits. When queried, William Panui reported that the sediment deposit over most of the parcel is less than 3 in. thick and that he had never found traditional Hawaiian artifacts at the parcel. Inspection also failed to reveal any petroglyphs on exposed *pāhoehoe* outcrops within the area of potential effect (APE). William Panui also reported that he hadn't discovered any petroglyphs on the parcel.

The unusual shape of the large rock platform, with its rounded corners, and the fact that it was built after the parcel's enclosing wall are two indications that it is a fairly recent construction. Dale Fergerstrom noted that a previous occupant was an amateur radio operator who built the large rock platform as a foundation for an antenna. According to Fergerstrom, the small rock platform marked the location of a guy wire anchor for the antenna. This information is consistent with field observations.

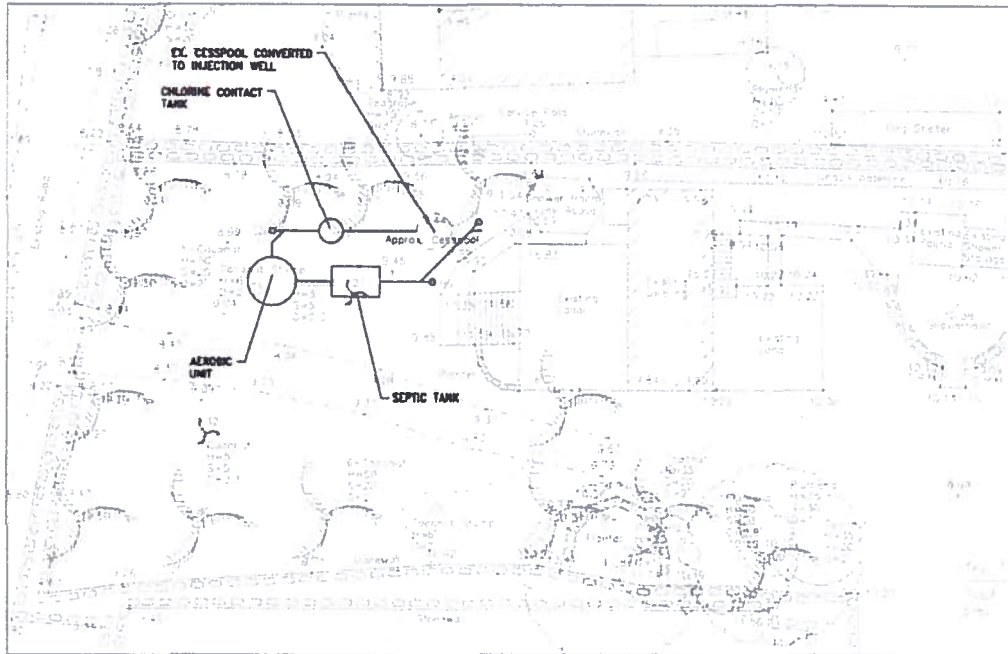
Figure 4: Engineering map showing the location of proposed wastewater facilities on parcel 30.

Wastewater system improvements are proposed for the front yard, *makai* of the existing dwelling. The area of potential effect for the wastewater system improvements is confined to the areas that will be excavated, as shown on figure 4, and to the driveway, which will be used to stage construction and lay down materials. The APE is an open yard with a shallow cover of calcareous sand that supports mature and young coconut trees and some grass (fig. 5). No evidence of a potentially significant cultural deposit was seen in eroding

sections of this sand deposit alongside the driveway. Rings of coral cobbles around some plants in the front yard are obviously recent constructions.

No petroglyphs were found on exposed patches of *pāhoehoe* lava within the APE at parcel 30.

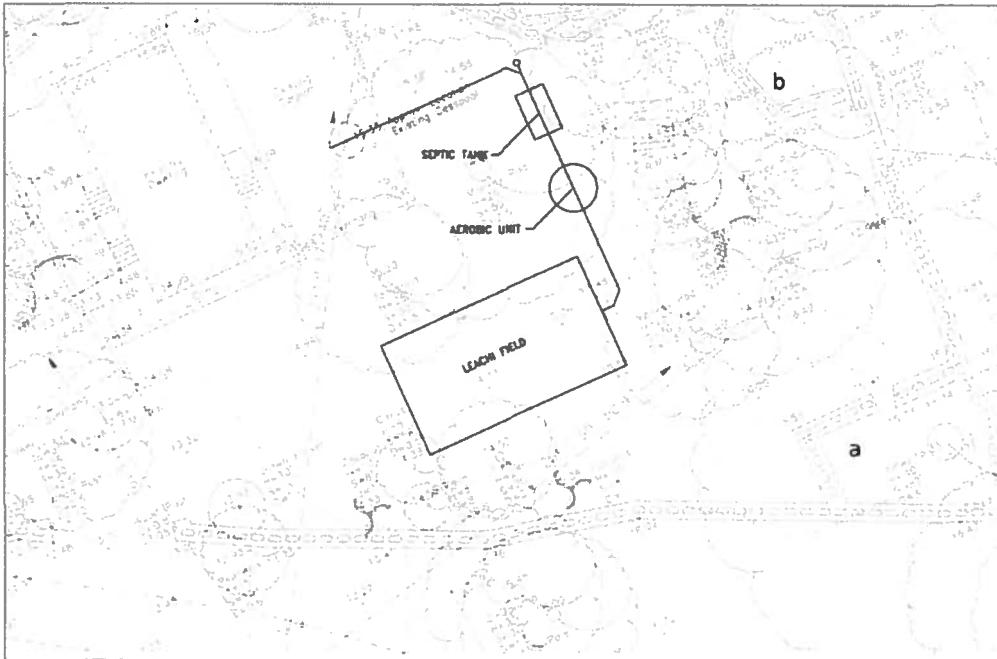
Figure 6: Engineering map showing the location of proposed wastewater facilities on parcel 33 and dry-laid stone masonry structures: *a*, platform; *b*, enclosure.

The entire lot is maintained as a yard with ornamental plants. It is surrounded with a dry masonry *stone* wall that roughly follows the lot boundaries. Bare *pāhoehoe* lava outcrops over most of the parcel. In addition, there are dry-laid stone masonry surface architectural features located near the APE. An enclosure (fig. 6, *b*) and a platform (fig. 6, *a*) both show on the engineering map. There is also a small semicircular enclosure (fig. 7), which does not show on the engineering map. No petroglyphs were observed on *pāhoehoe* outcrops at or near the APE.

Field observations indicate that the enclosure wall abuts the lot boundary wall and thus postdates it. It was not possible to determine the stratigraphic relation of the platform

with the lot boundary wall without excavation. Field observation of the small semicircular enclosure did not yield any information about its age or function.

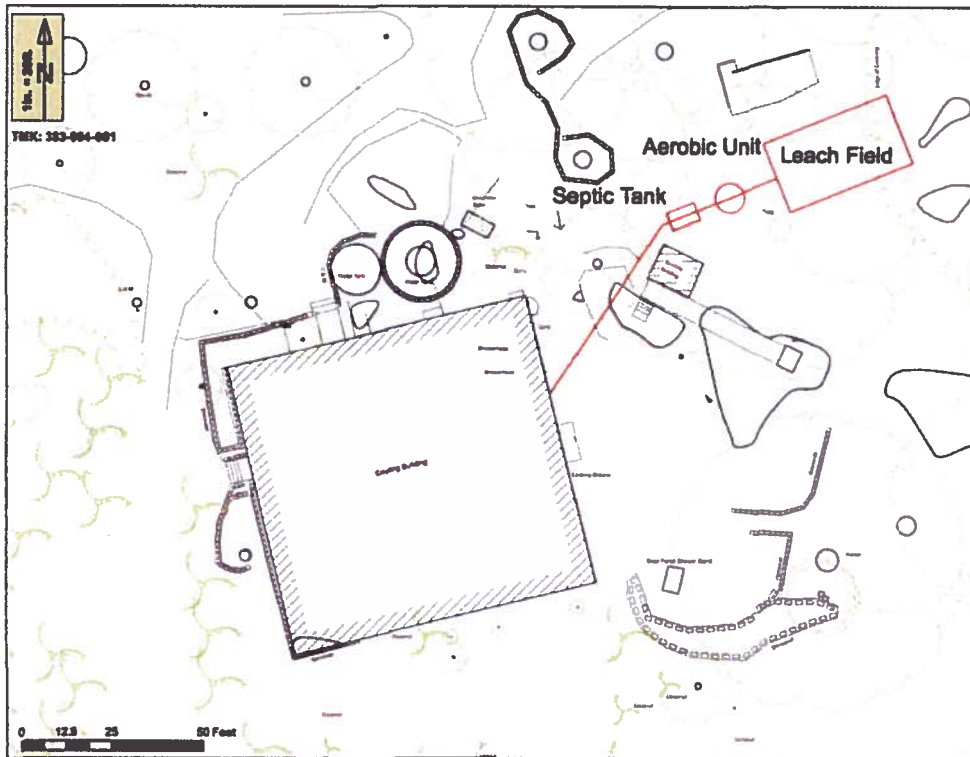
Figure 8: Engineering map showing the location of proposed wastewater facilities at Halau Maluhia.

Halau Maluhia is a facility owned and operated by Kamehameha Schools. It consists of a large, open building serviced by several outbuildings that include outhouses and showers. The wastewater system improvements are proposed for a location northeast of the large open building (fig. 8). The APE for the wastewater system improvements is confined to areas that will be excavated and to the driveway and parking areas, which will be used to stage construction and lay down materials. The APE is in an open area of undulating *pāhoehoe* lava that was modified during construction and maintenance of Halau Maluhia. Today, it is partially covered with secondarily deposited material (fig. 8).

Field observation of the APE yielded no evidence for potentially significant historic properties. The various stone walls that show on the engineering map (fig. 8) are all
